What the Homeowner Wanted

What Was Done

The original kitchen was only 180 square feet in size with an adjoining breakfast nook and a small combined laundry room/pantry/storage closet. The new design included removing the interior walls of the breakfast nook and laundry room to create a combined area of 284 square feet.

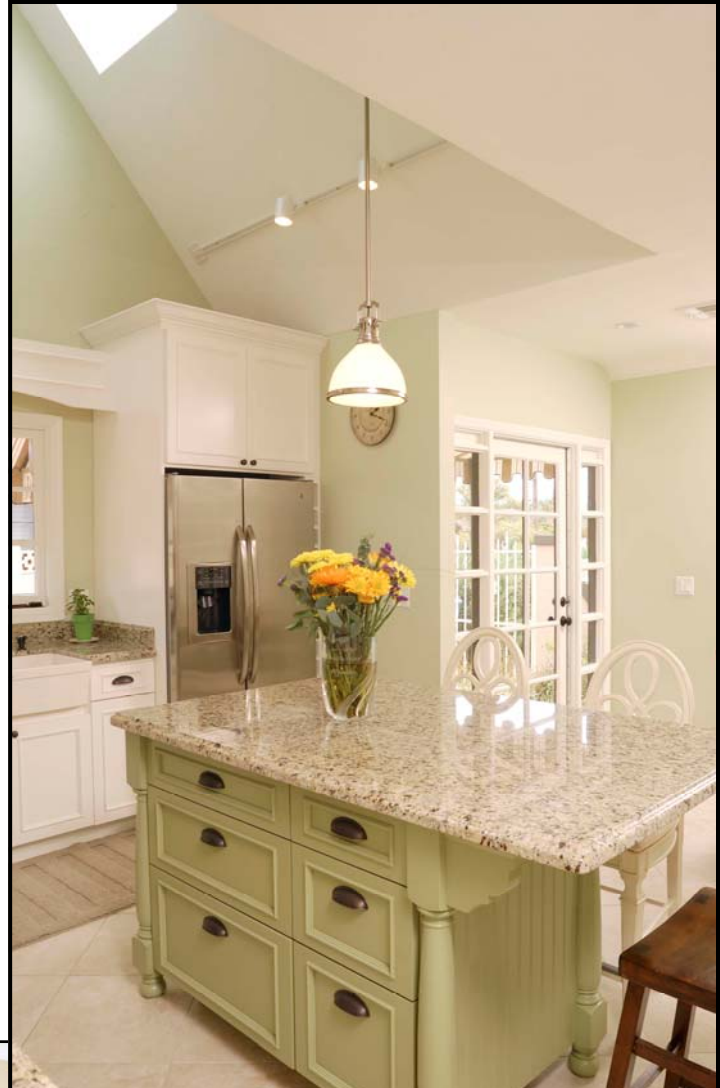
After

- The peninsula, built-in hutch and built-in desk were eliminated
- The soffit was removed in the kitchen to match the ceiling height between the entry way, the breakfast nook, and the laundry room

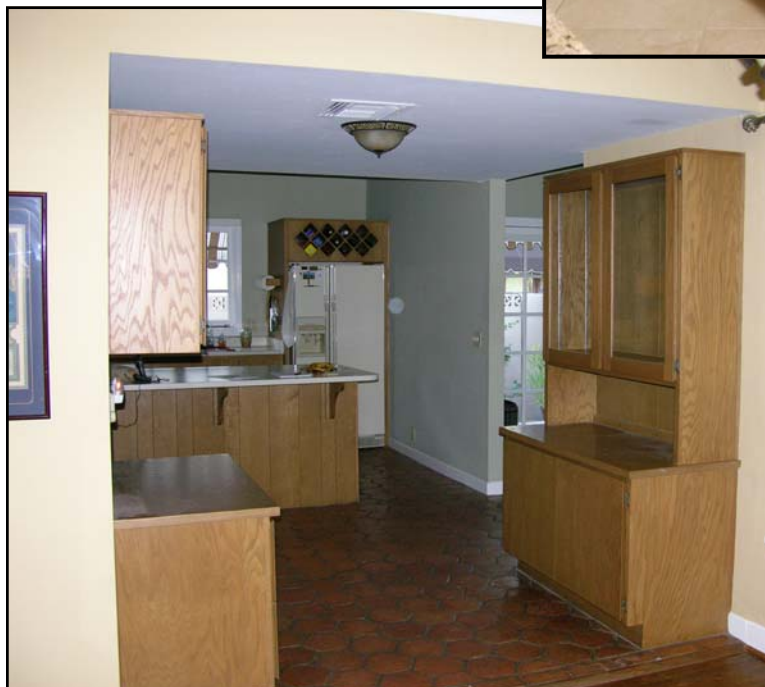
Before

The kitchen used to be a small confined area that didn't allow much room for more than 1 person to work. The ceiling height and small room sizes created a dark and enclosed feeling.

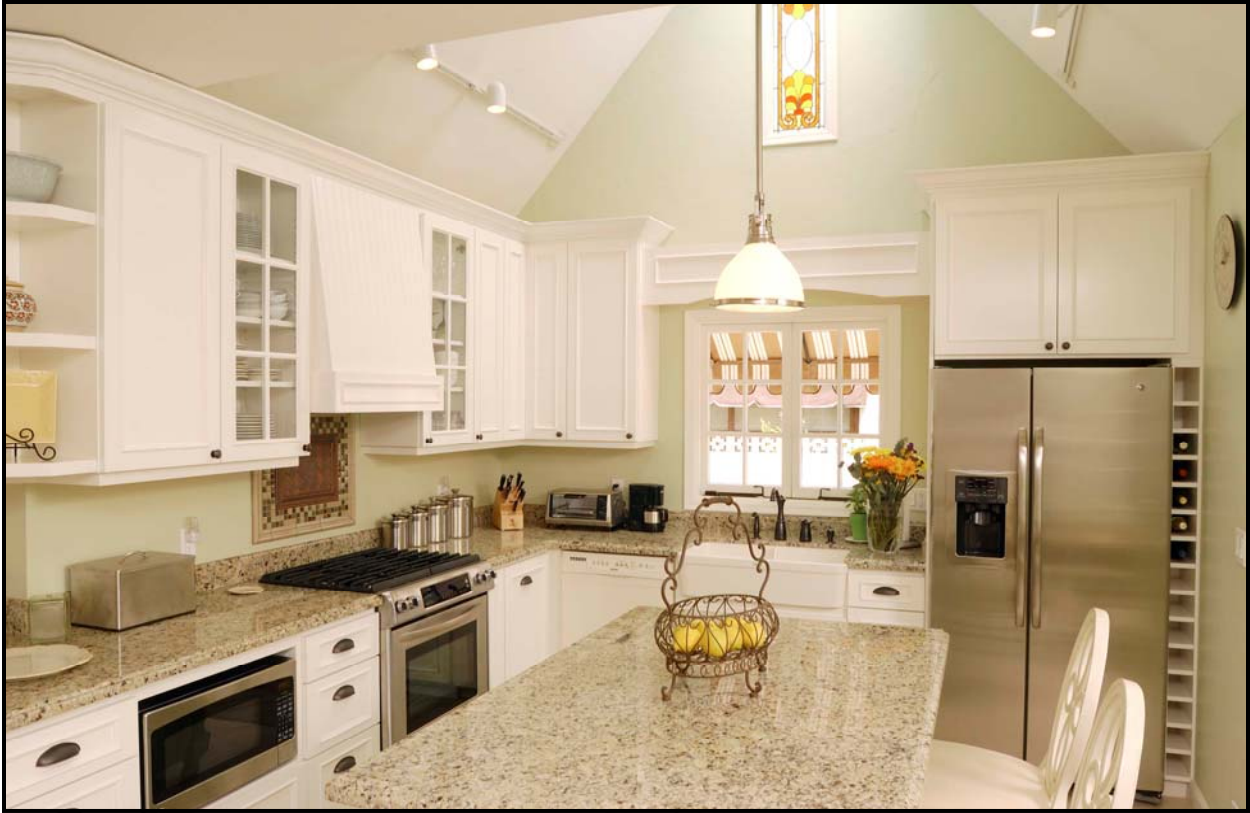
After

The new kitchen provides a large area for multiple cooks as well as plenty of space for social gatherings around the new island.

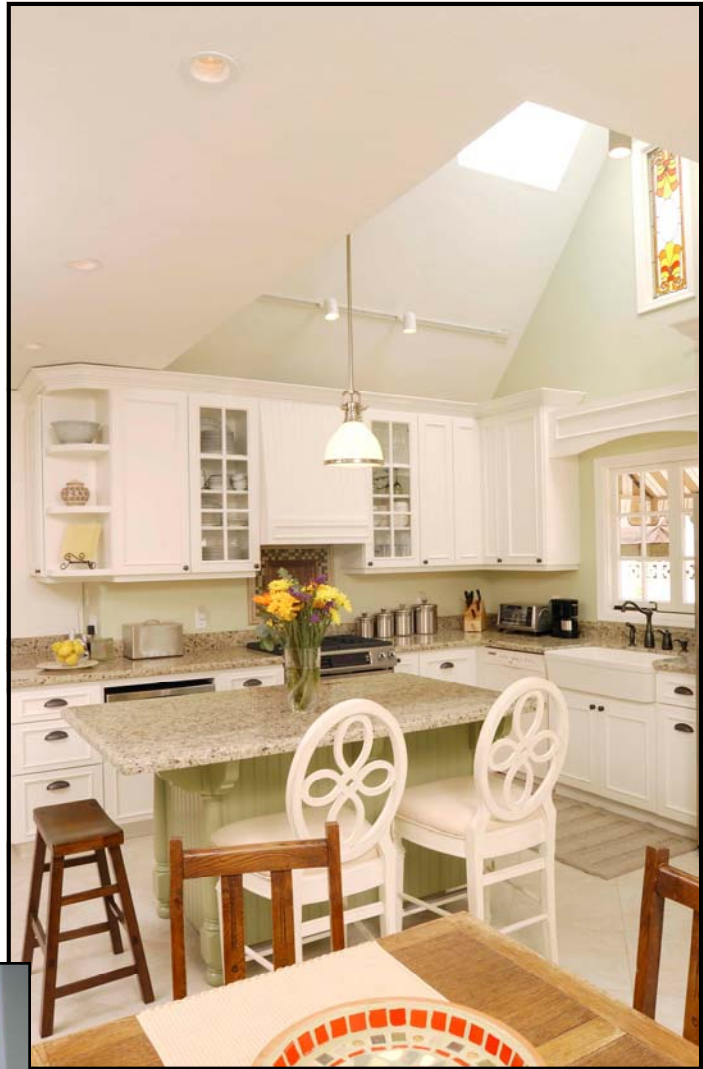
After

The ceiling fan was removed and a pendant light was installed in its place. The soffit was removed to make room for the custom 42 inch upper cabinets.

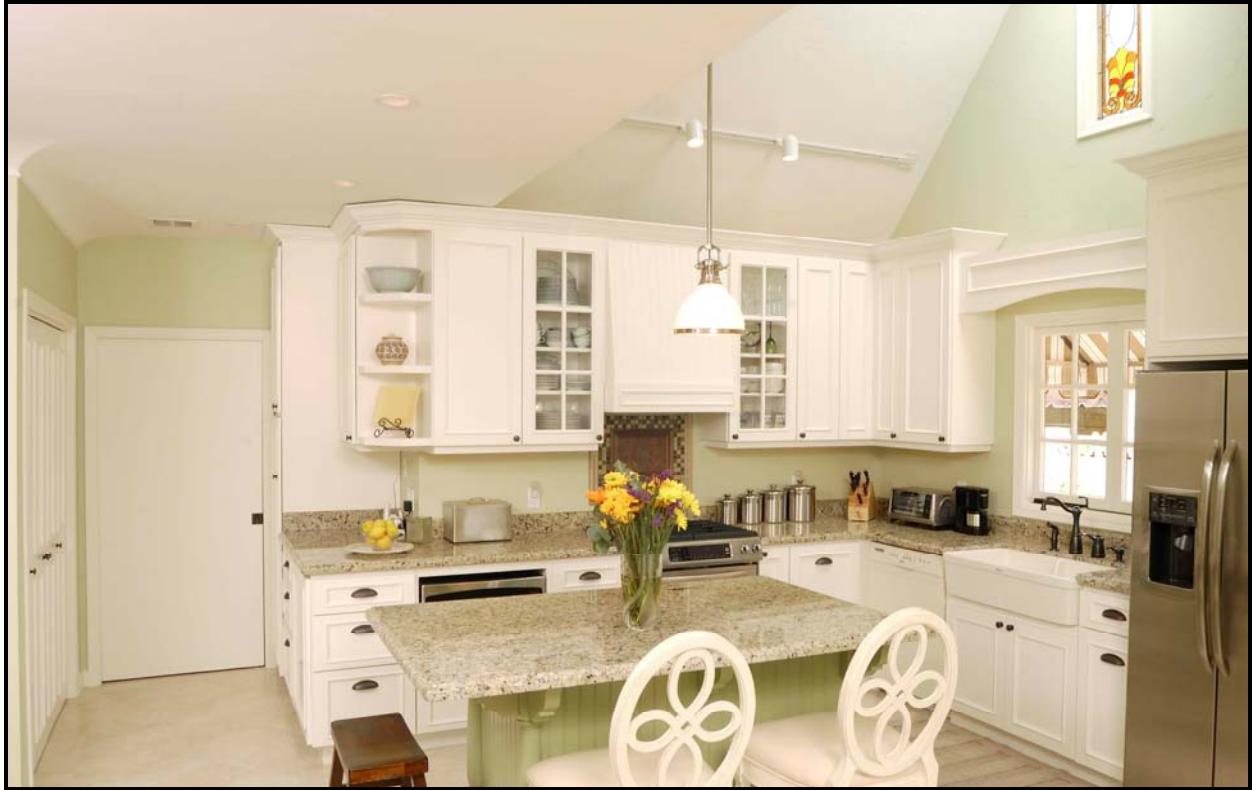
After

The washer and dryer are now housed behind a bi-fold door retrofitted to match the custom cabinets.

The farm house sink and country faucet kept the old-fashioned look the homeowner wanted to preserve.

The flooring blends with the rest of the room and helps to lighten the entire area.

The crown molding and the arched bridge over the window add an interesting level of detail and helps keep the scale of the room in perspective.

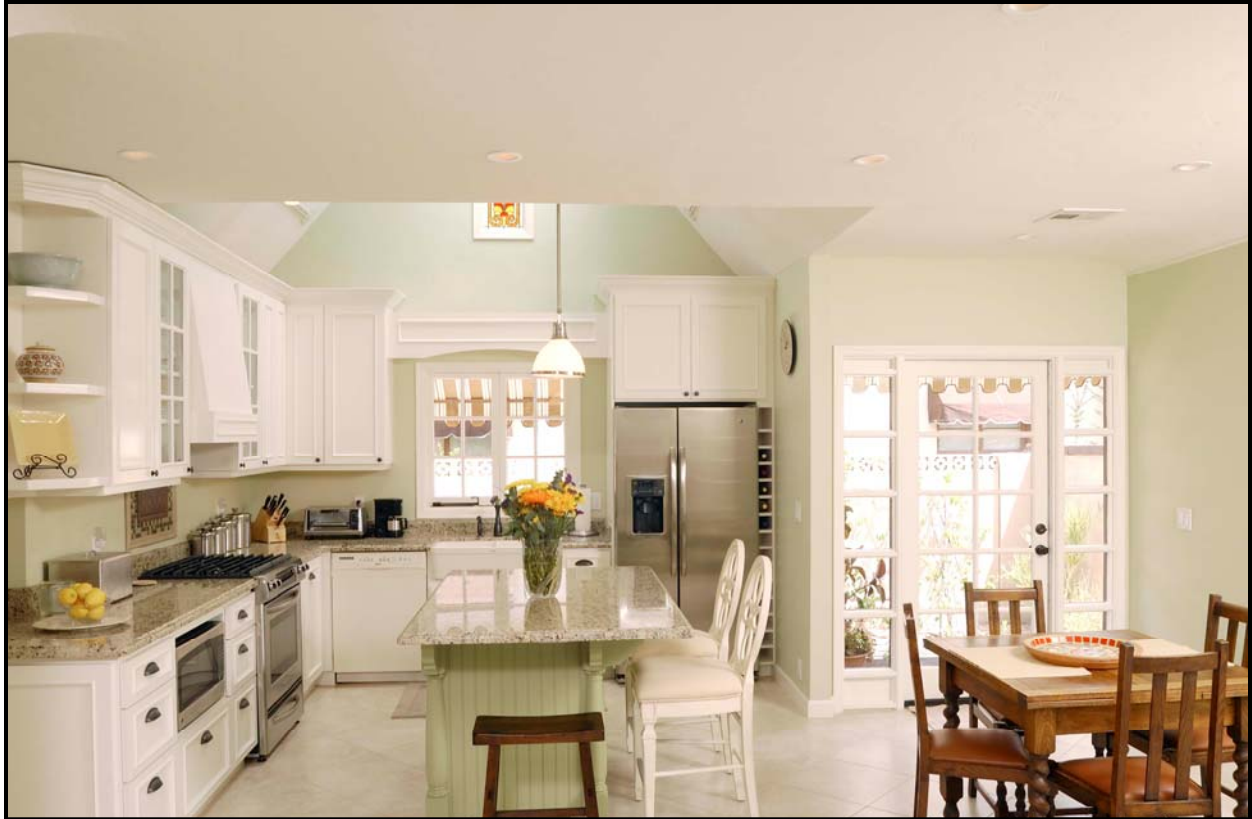
After

The French door is now a light source for the entire kitchen area where before it was cut off by the breakfast nook walls. The dining table is now an integral part of the kitchen instead of being tucked behind a wall. The kitchen is now the hub of the house and perfect for entertaining multiple guests.

The old laundry room wall and peninsula were removed and the ceiling was modified to flow seamlessly between all the remodeled areas.

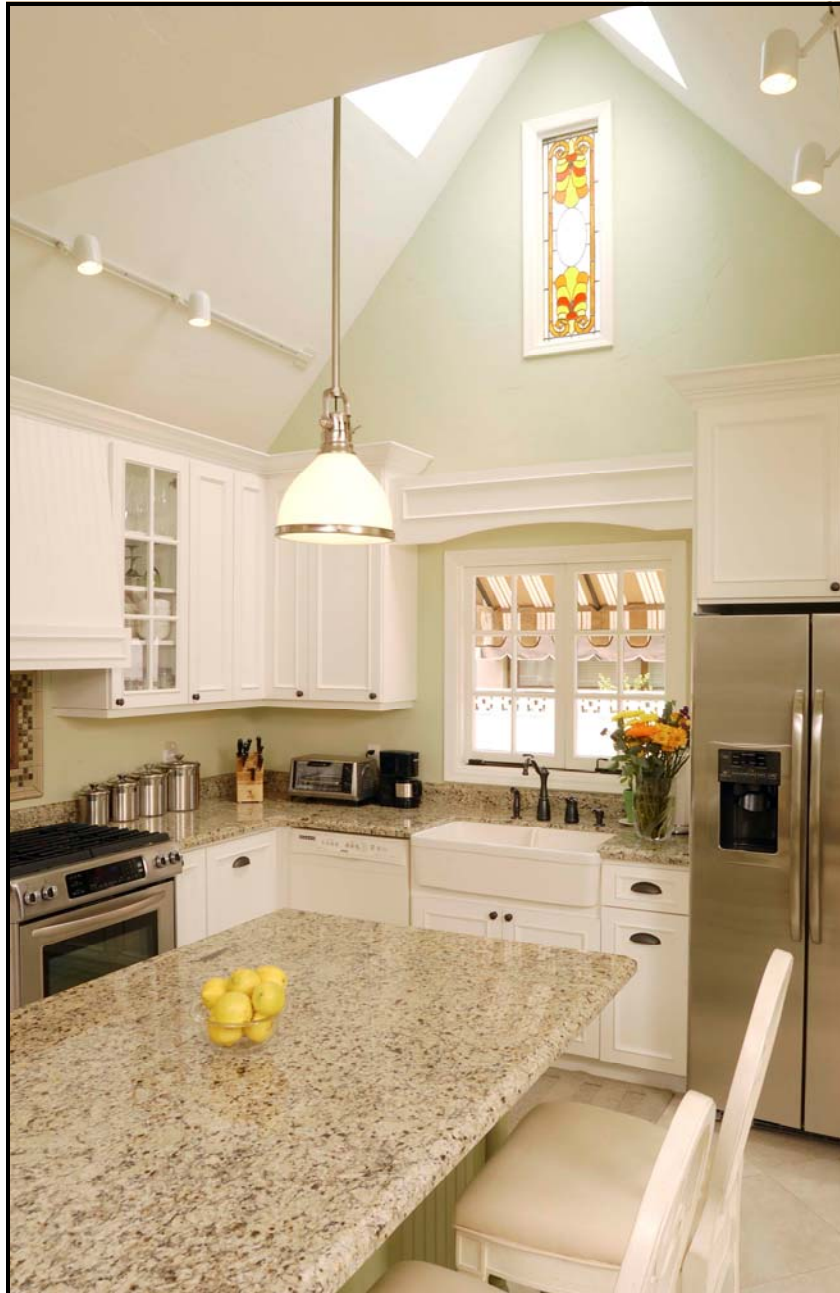
The 62" x 38" island countertop provides plenty of work space for food preparation and adds seating for 3. The existing kitchen window and skylights are now features in the new kitchen being highlighted by the white cabinets against the light green wall color. The colors of the existing stained glass accent window coordinate with the new decorative tile backsplash above the stove.
